Limited Phase II
Environmental Site Assessment

251 Searingtown Road

North Hills, New York

February 18, 2013
Revised: November 13, 2013

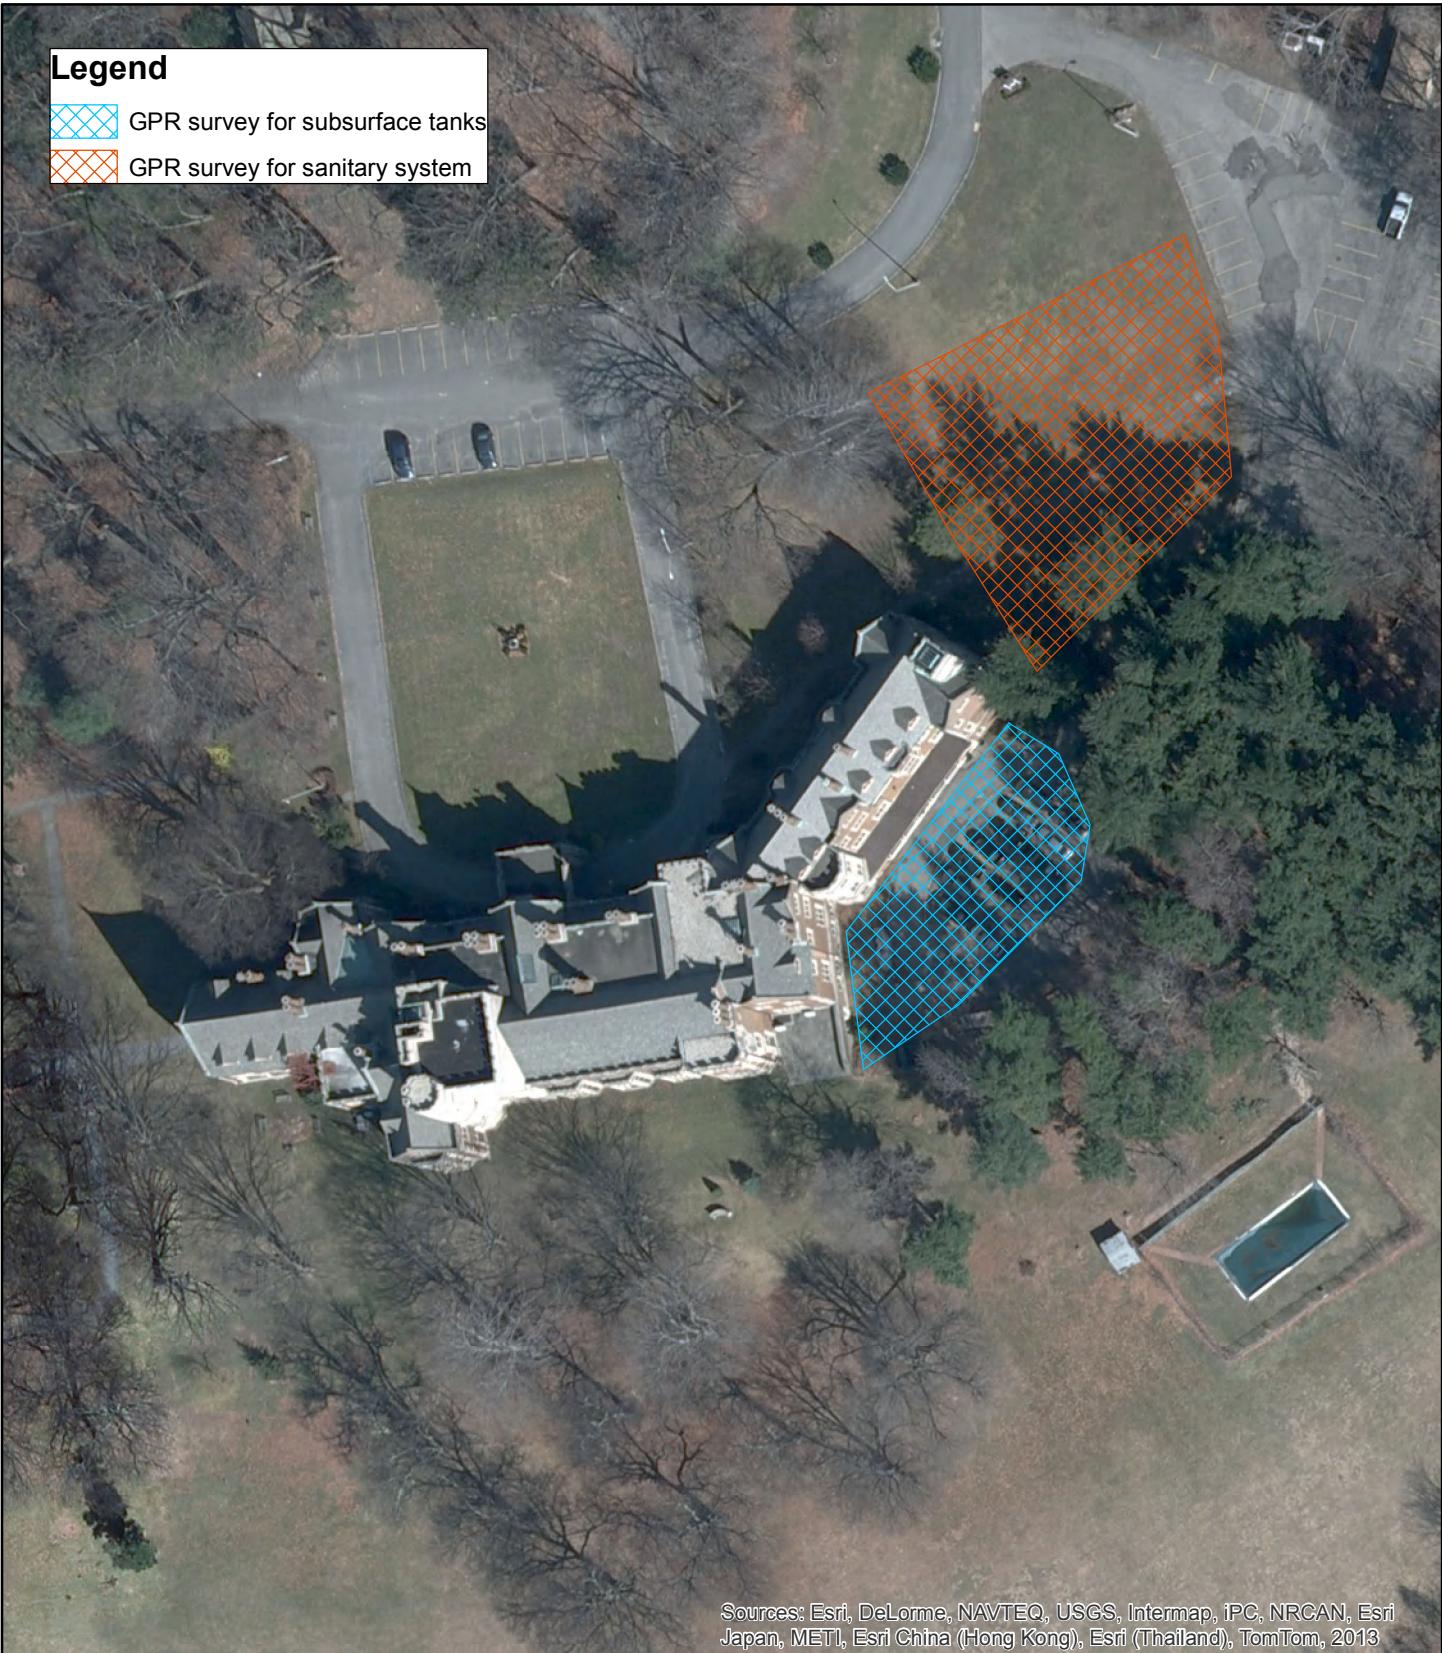
**FIGURE 1
GPR SURVEY MAP**

-

GPR survey for subsurface tanks
-

GPR survey for sanitary system

The GPR was also utilized to potentially identify the location of the former on-site sanitary system. This survey was completed by dividing the property into a grid and traversing the property with the GPR unit along the grid lines. The "grid" lines were setup in three (3) foot intervals along the north-south and east-west axis of the property. This survey detected several anomalies which may have represented a typical subsurface leaching structure. In order to confirm if a subsurface structure was present, test holes were dug in the areas of the anomalies. None of the test holes dug identified the presence of subsurface structure. The areas which were dug up did contain numerous large stones. **Figure 1** provides an aerial photograph which identifies the areas of the property that were surveyed.

2. A GPR survey was conducted off the east side of the house in order to locate the former on-site sanitary system and in the area of the rear driveway/parking area to determine if any underground storage tanks were present. The survey for the sanitary system identified several anomalies. In order to determine if any structures were present, the ground in the area of the anomalies was excavated but no subsurface structures were present. The survey for the underground tanks (see Figure 1) did not identify any anomalies typical of an underground storage tank.
